Final Report

Passive Cross Laminated Timber Buildings

Cerbof-project no. 76

April 2013

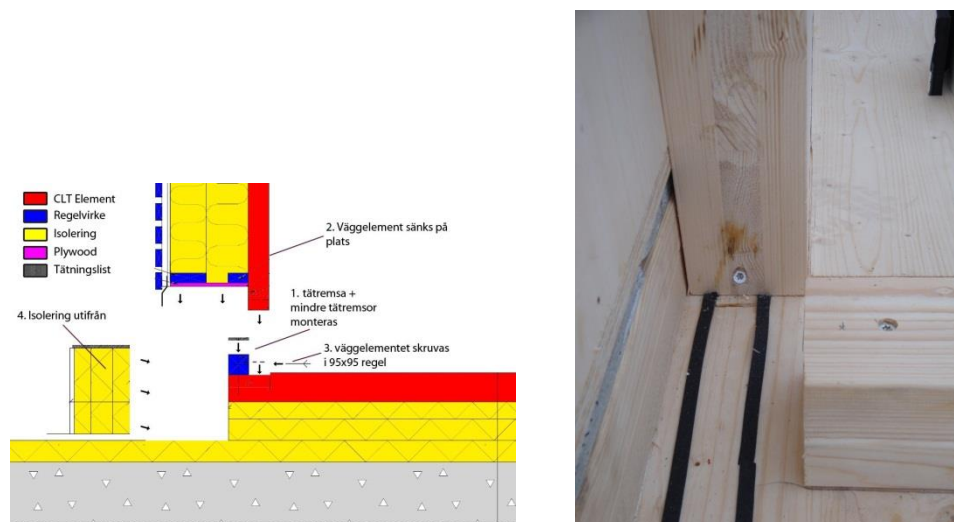
Figure1: On the left: Example of junction between wall panel and floor where the sealing strips and the formation of the junction to give an indirect route for air movement between inside and out reduce the air leakage (Fyhr, 2012). On the right: Junction between wall panel and floor where the wall panel is placed on the sealing strips in a rebate cut out of the floor panel.

Reduced air leakage from the joints between the panels. All of the panels are constructed so that the air, in case of possible leakage, has to follow an s-curve, which increases the resistance to unwanted air movement and reduces leakage, see figure 1. For example the wall panel is fixed to the floor by a shallow rebate being cut in the floor panel into which the wall panel is lowered. This rebating is combined with expandable sealing strips which are fitted together with the assembly of the elements. However, it should be pointed out that the form of the joint to reduce the air leakage has not been preceded by theoretical calculations but is a solution based on the builder's own experience. The rebates also reduce the possible visible gaps between the panels which reduces the need for cover strips to hide the joints later for aesthetic reasons.

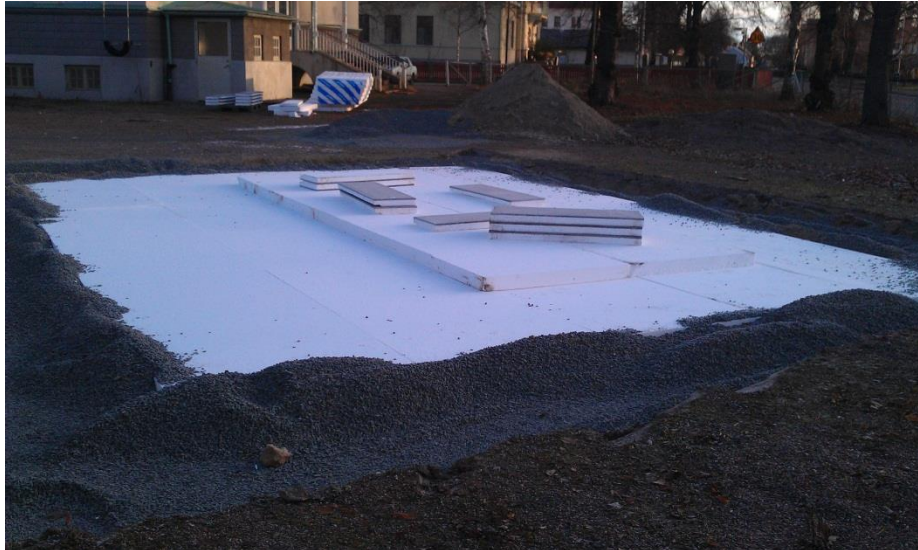
Figure 2. The foundation of the test building before the CLT panels have been laid. The cellular plastic boards with fibre cement cladding which are laid over the foundation are to hinder the cellular plastic boards from being blown away.

A new method of constructing the foundations. The foundation in the test building consists of packed gravel with 300mm cellular plastic boards and 130mm CLT panels on top, see figure 2. The foundation was raised somewhat to avoid moisture and was clad with edge elements of fibre cement boards glued to cellular plastic. This foundation method has a good level of insulation and the CLT panels spread the load on the ground in the same way as concrete which means that the CLT panel replaces a concrete slab, which thereby makes it an inexpensive solution even if no economic analysis has been made within this project. The system ought to work for modular building units, not only for flat element systems, and can even be a possible solution for more temporary buildings, e.g. temporary schools and health care facilities. This method could also be a way of constructing the foundations for permanent buildings of up to two storeys; buildings higher than this are estimated as being too heavy, but the method must be tested in more detail before it can be proposed for live projects. The evaluation of this foundation method is not included in this project.

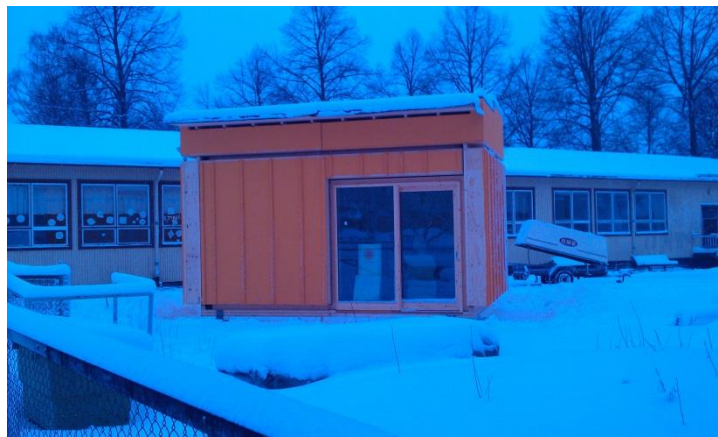
Figure 3. Test building in the twilight the day after the assembly. The joints between the wall and roof elements remained to be completed as did the external boarding.

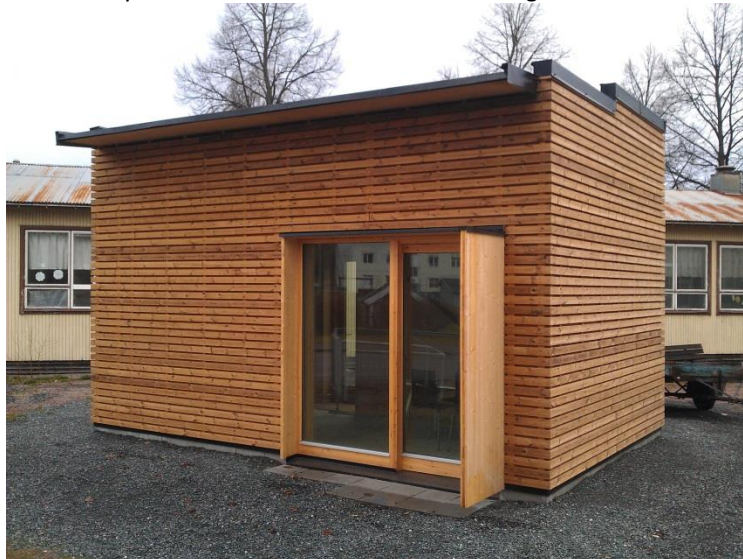
Figure 4. The test building with sliding doors on the south when the exterior was complete.

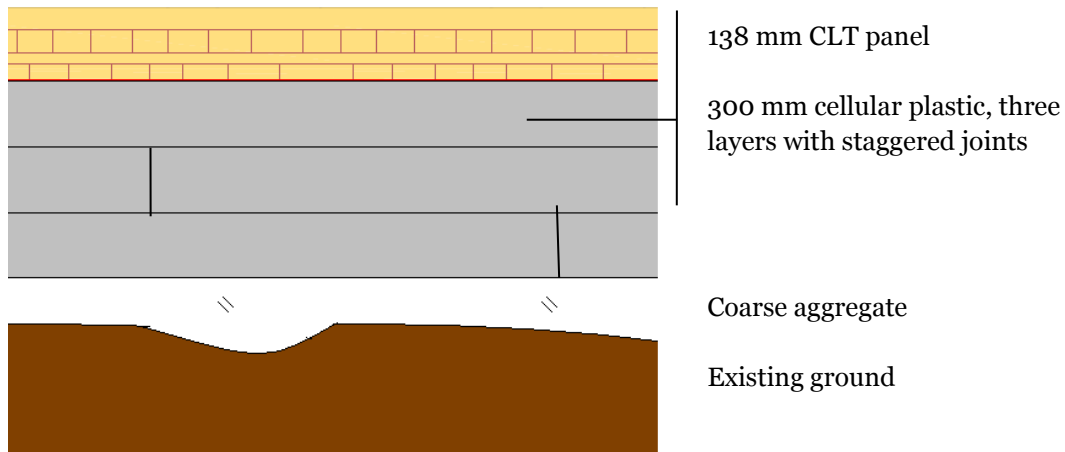
Figure 6: Foundation construction for test building.

The construction of the foundation was not a traditional concrete slab on the ground. It consists of a lightweight construction where the concrete slab is replaced by a 138 mm thick CLT panel with an underlying layer of cellular plastic which gives an average U value of 0.089 [W/m².K]. The edges of the foundation structure have been fitted with fibre cement clad cellular plastic boards. In view of its light weight the foundation is anchored by four earth anchors to prevent the foundation from moving under high wind loads. The earth anchors are attached to fittings in the CLT foundation panels.

The foundation construction was tested because the test building has a temporary building permit, with a requirement for a mobile foundation construction which can be disassembled quickly and simply. Furthermore, there is also a general need to find energy efficient foundation designs for provisional buildings where there is a requirement for mobility. Figure 6 illustrates the construction of the foundation.

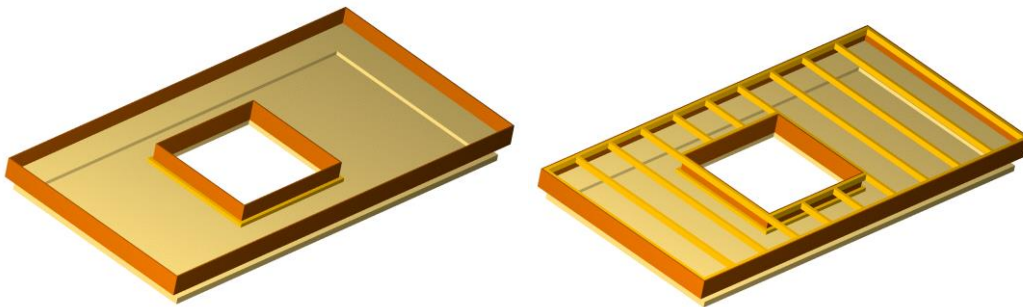
Figure 7. Stora Enso's external wall with insulation box.

The external wall consists of a load bearing CLT panel on the inside. The insulation is placed in an insulation box which is constructed outside the CLT panel to reduce the cold bridge. On the outside of the insulation box there is a layer of studs which in turn supports the exterior plasterboard and the façade material. The external walls and the roof are prefabricated in the factory and lifted into place by a mobile crane. When the building is assembled the façade material is nailed into place. Figure 7 illustrates how the wall is built up.

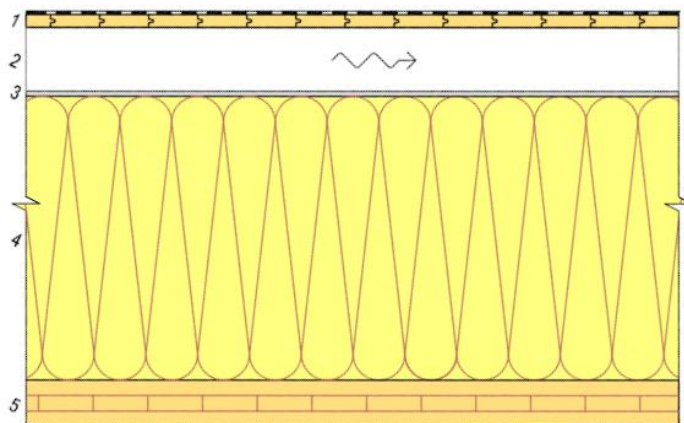
1. Roofing, tongued and grooved boarding and roofing felt
2. Air cavity, varying width
3. Wind barrier
4. Insulation with lightweight joists
5. CLT panel

Figur 9: Stora Enso's roof construction

The roof consists of, from the inside, a 138 mm CLT panel, 500 mm insulation in boards, wind barrier and roof covering and has an average U value of $0.075 \text{ [W/m}^2\cdot\text{K]}$. The roof construction is illustrated in figure 9.

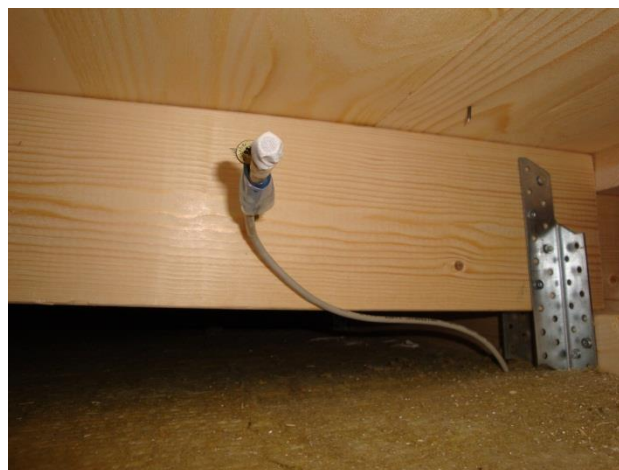
Figure 10. An example of the placing of a sensor, in this case the sensor in the air cavity in the roof.

Two sensors (nos. 3 and 13) have been placed in the intersection of the north and east wall elements in order to study possible leaks in the junction between the elements. These sensors are placed in the upper part of the wall, on the inside between the CLT panel and the insulation, and on the outside between the insulation and the exterior plasterboard. In the same way, sensors have also been placed at the fixing of the sliding door screen and the entrance door. Furthermore four sensors have been placed (nos. 8, 9, 2 and 4), see figure 11, in the roof of the building directly over the joint in the elements. This joint is considered to be a critical point with regard to the risk for condensation if the joint does not remain completely airtight. The sensors are placed, from the inside, in the junction between the CLT panel and the insulation, in the middle of the insulating layer, in the upper edge of the insulation and also in the air cavity in the roof construction, see figure 10.

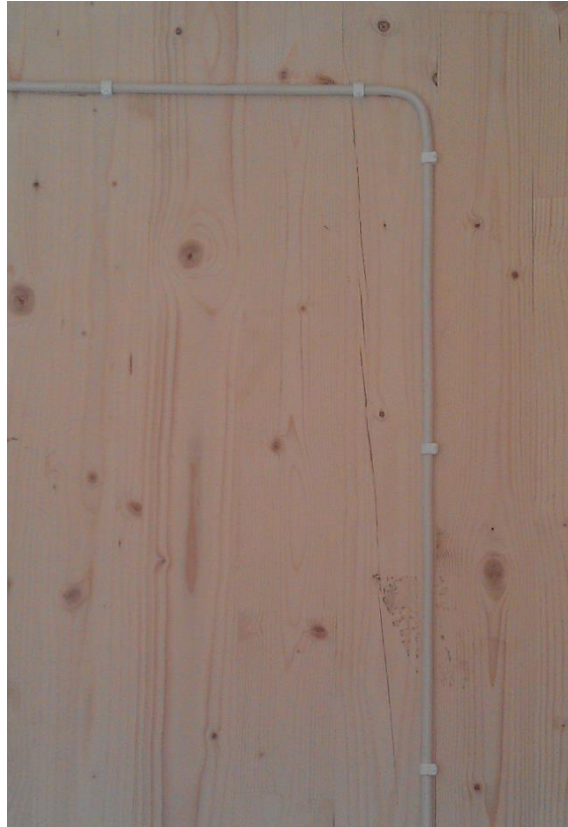
Figure 12. The picture shows cracking in a CLT panel approx. five months after the assembly of the building. However, thermography in connection with pressure testing shows no sign of this cracking causing any extra air leakage, partly because the CLT panel is built up of several layers.

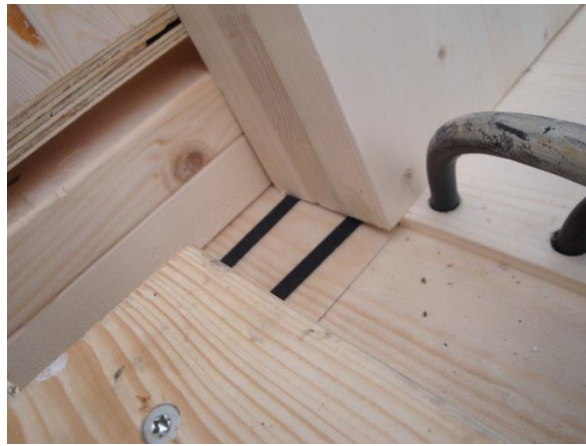
Figure 13: During assembly the wall elements got stuck on the edge of the reveal in the foundation element.

- The position of the lifting loops caused problems in assembling the wall elements as they hung asymmetrically which caused an angle when they were sunk down towards the floor. This meant that it was difficult to lower the panels into the rebate which had been prepared in the foundation panels, see figures 13 and 14.

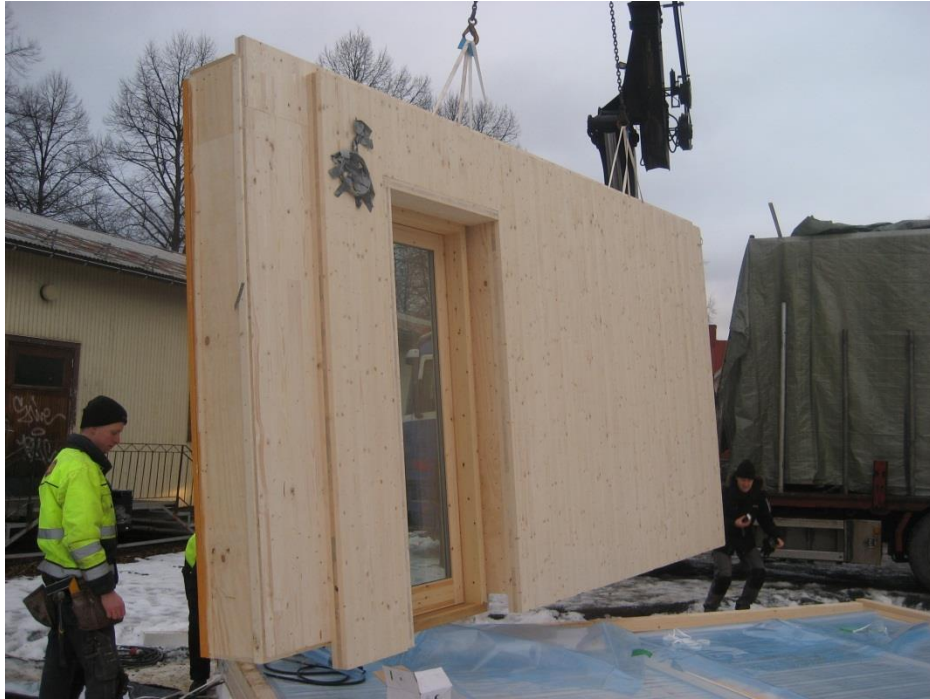
Figure 14. Assembly of the north wall. The position of the lifting loops means that the wall leans somewhat which makes placing it on the floor element more difficult.

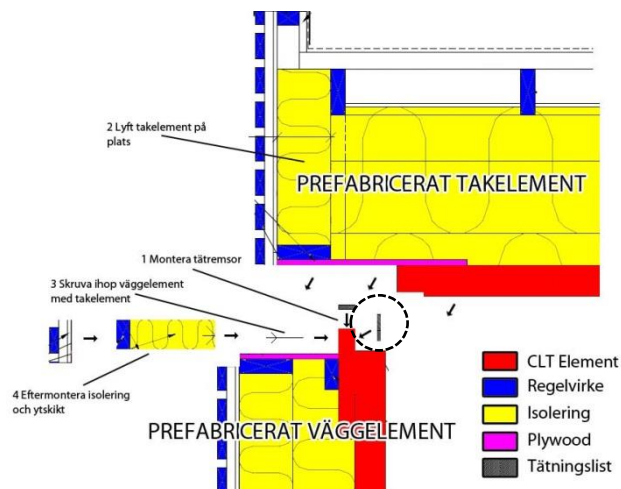
Figure 15: Detail of joint between roof and wall elements. The sealing strip which tended to be in the way and to be damaged when the roof was laid on top is shown by a circle.

- The position of the sealing strips should be studied in more detail. This is particularly important in the joint between the wall and roof where the roof had a tendency to fasten in one of the sealing strips and pull it down. See figure 15 below:

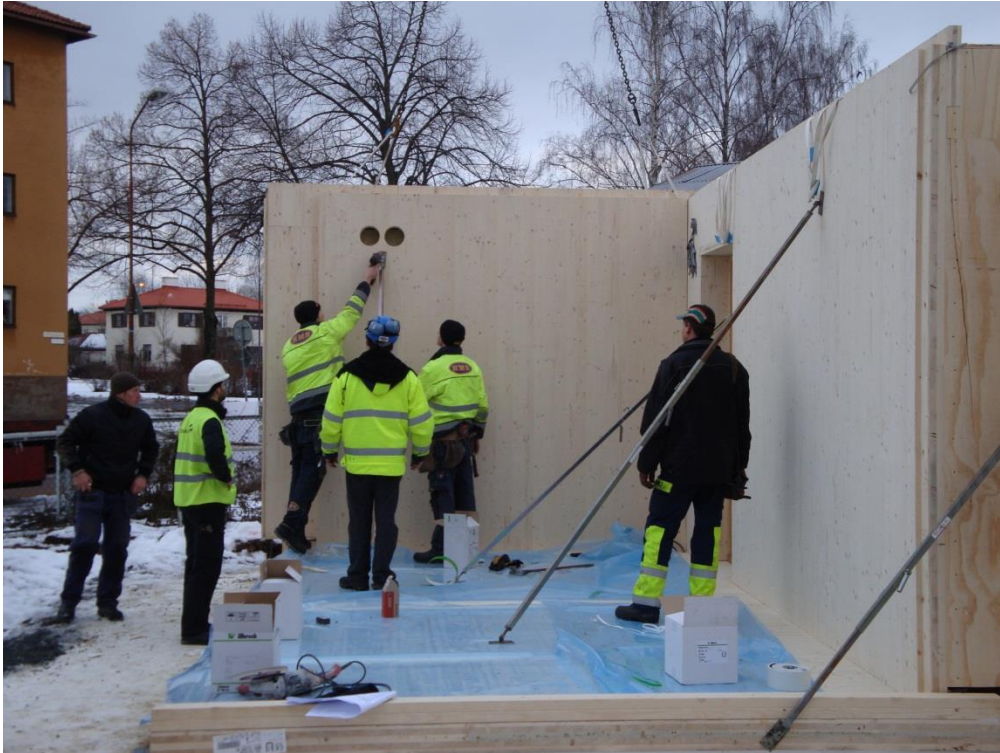
Figure 16. Assembly of the west wall.

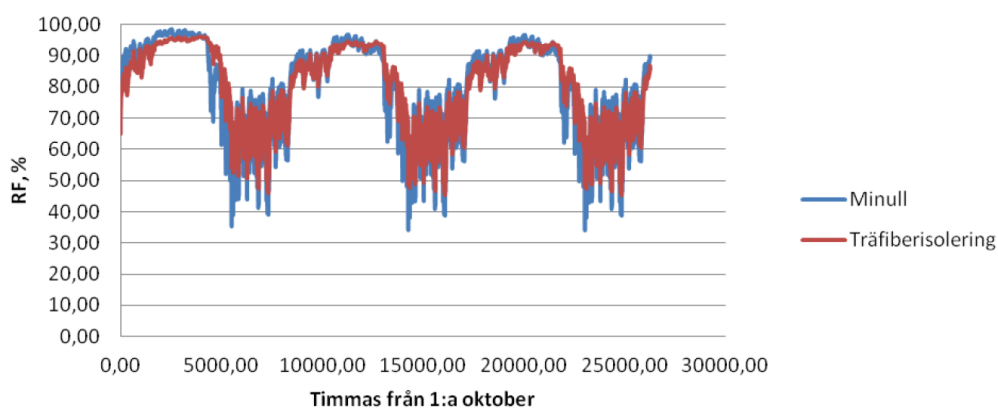
Figure 17: Relative humidity in the junction between the insulation and exterior plasterboard with mineral wool and wood fibre insulation respectively in the wall.

In connection with the design of the test building, two simulations of relative humidity were carried out to estimate theoretically the effect of internal and external humidity on the construction. After the follow-up measurements these will be compared with the measured data. Simulations were carried out with the requirement that that no plastic sheet should be used, and two different sorts of insulation based on wood fibre or mineral wool were also used. The first simulation studied changes in the relative humidity throughout the section of the wall and also how the relative humidity differed depending on the insulation material chosen. Figure 17 shows the relative humidity over time in the section exterior plasterboard/thermal insulation. In this section the results are quite similar regardless of the chosen insulation, but a somewhat larger moisture movement can be noted when the wall is constructed with mineral wool. Furthermore it can be noted that the relative humidity is around 90-95 % during certain periods.

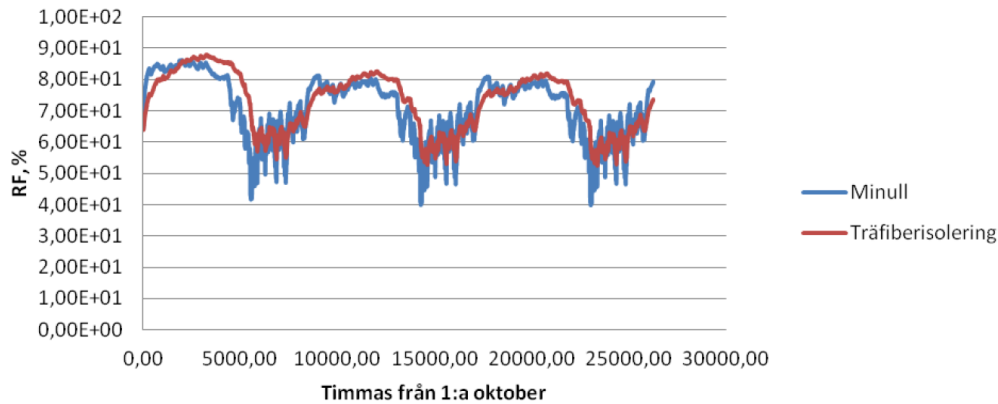
Figure 18: Relative humidity in the thermal insulation, 50 mm in from the exterior plasterboard with mineral wool and wood fibre insulation respectively in the walls.

Figure 18 below shows the relative humidity in the thermal insulation 50 mm in from the exterior plasterboard. The simulation shows that the resulting relative humidity in the wood fibre insulation is somewhat delayed compared with the mineral wool and fluctuates somewhat less than in mineral wool.

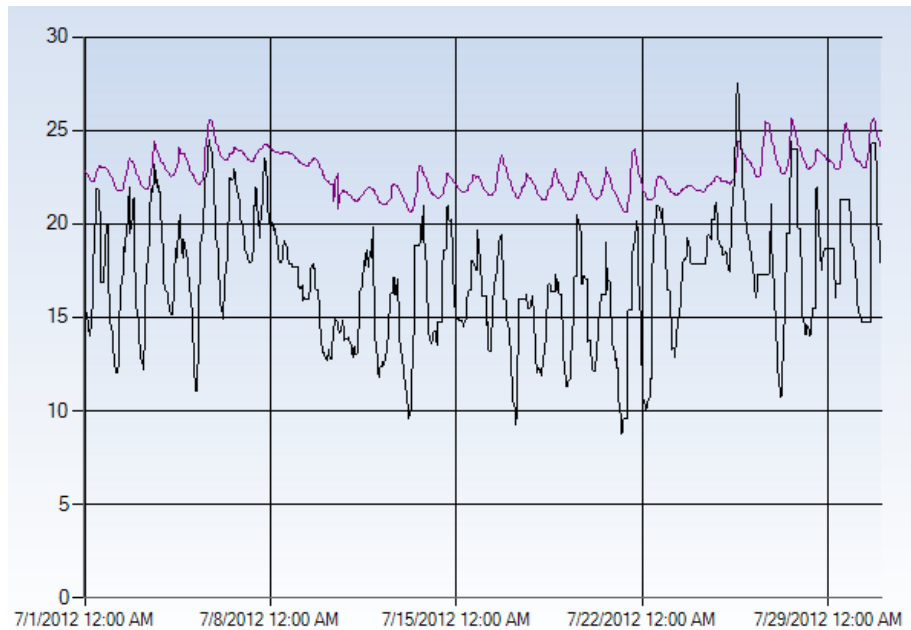
Figure 23. Indoor temperature (purple line) and outdoor temperature (black line) in the test building during July 2012.

It is too soon to evaluate the measurements of the indoor temperature as the measurements have only been carried out for six months. Figure 23 shows the temperature in the test building during July 2012 when the building is neither heated nor cooled. The black line shows the outdoor temperature and the purple line the indoor temperature. The figure shows that there was an even and relatively constant indoor temperature (21-25.5 °C) although the outdoor temperature varied quite substantially (10-27 °C). Longer series of measurements also made during a longer colder period are needed to be able to evaluate the possible heat storage capacity and how this affects the indoor temperature.

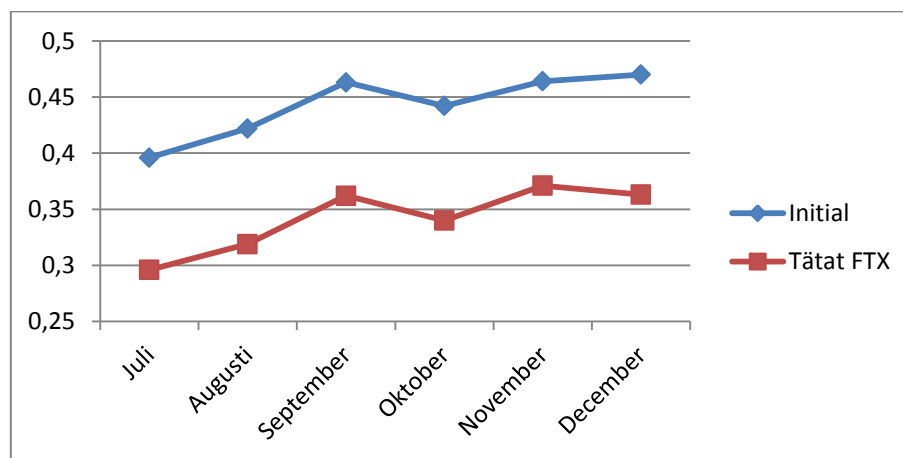
Figure 24: The result of the initial pressure tests with sealing on the outside of the duct and also the result of the pressure tests with sealing on the inside of the HRV unit. Measurements made during 2012.

The results of the measurements show that the leakage from the HRV unit's duct contributed approx. 0.1 [l/m².s], regardless of when the measurement was carried out. There is, however, one exception in the measurement in December where the difference between the measurements was somewhat larger. This is probably due to its being cold when the measurements were carried out with a lot of frost on the outside of the fan duct which contributed to the difficulty of getting the sealing to remain in place during the initial measurement.

The air leakage for the measurement with a sealed HRV unit, which is also the measurement which shall be compared with the present air tightness requirement, was, to begin with, 0.29 [l/m².s], but rose during the autumn to level off later. At present, it is difficult to judge if we have now reached a final level of 0.36 – 0.37 [l/m².s] for the leakage from the building or if it will continue to vary over time. There will probably be continuous variation in the leakage from the building dependant on the effect of humidity and the following drying out/humidifying of the building envelope. However, an important question which remains to be answered is the appearance of these changes over a longer period of time.

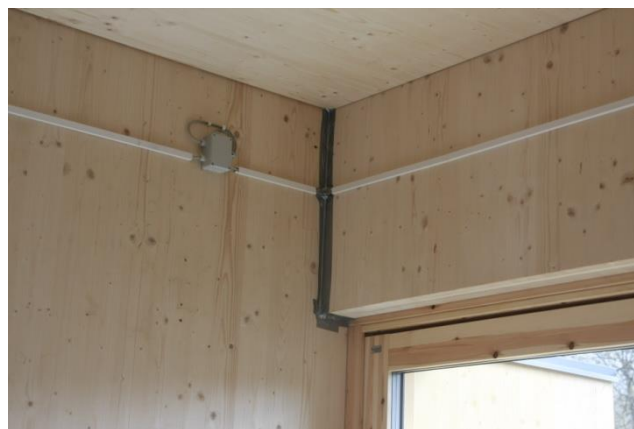
Figure 25: Temporarily sealed joint in the elements above the sliding door screen. This joint has not been sealed during the recurrent air tightness tests.

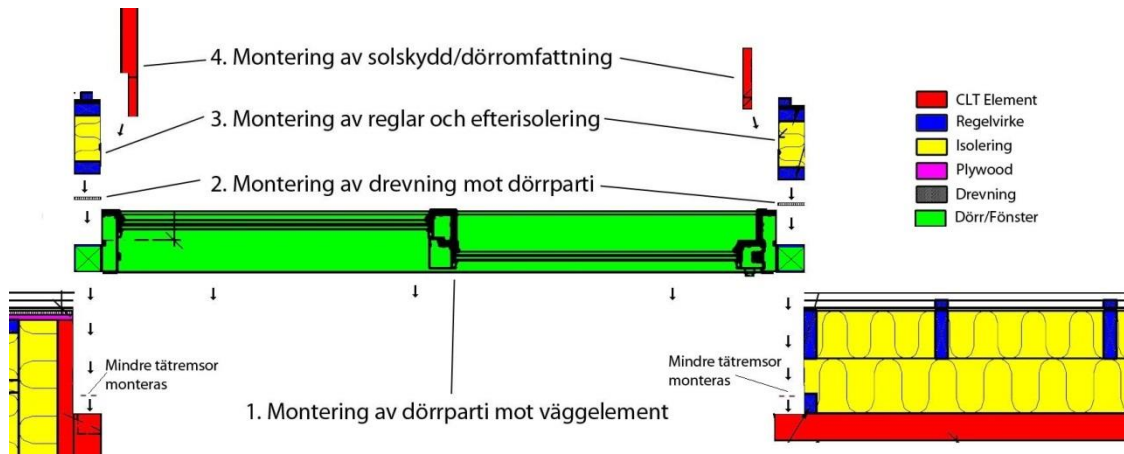
Figure 26: The order of assembly of the sliding door screen in the wall element (Fyhr, 2012)

Regarding the entrance door, which contributed 34 % of the air leakage, it was designed to be further out in the wall compared with the sliding door screen and its fixings, which were shown to be very airtight in the measurements, see figures 26 and 27.

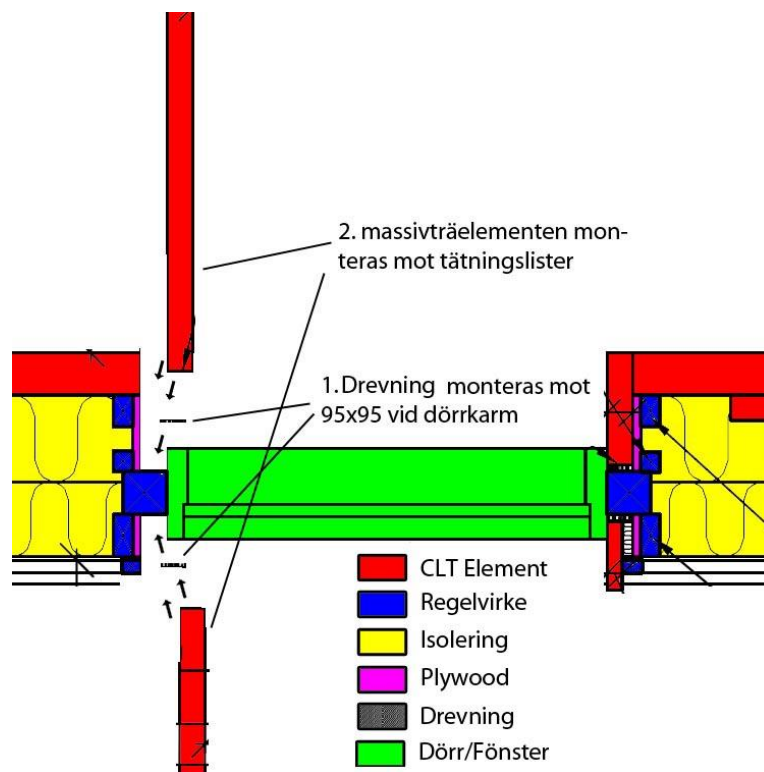
Figure 27: The assembly of the entrance door in the wall element (Fyhr, 2012)

The position of the entrance door towards the outside of the wall was one reason why door linings of CLT had to be added on site, when one of the internal door linings was extended to create a screen in the room. In comparison with the sliding door, the position of the entrance door contributed to several potential leakage points through the junctions between the CLT panel, the door linings and the entrance door. As the CLT screen was assembled on site it was more difficult to move it against the studs in the doorframe and create an airtight joint compared with the fixing of the sliding door.

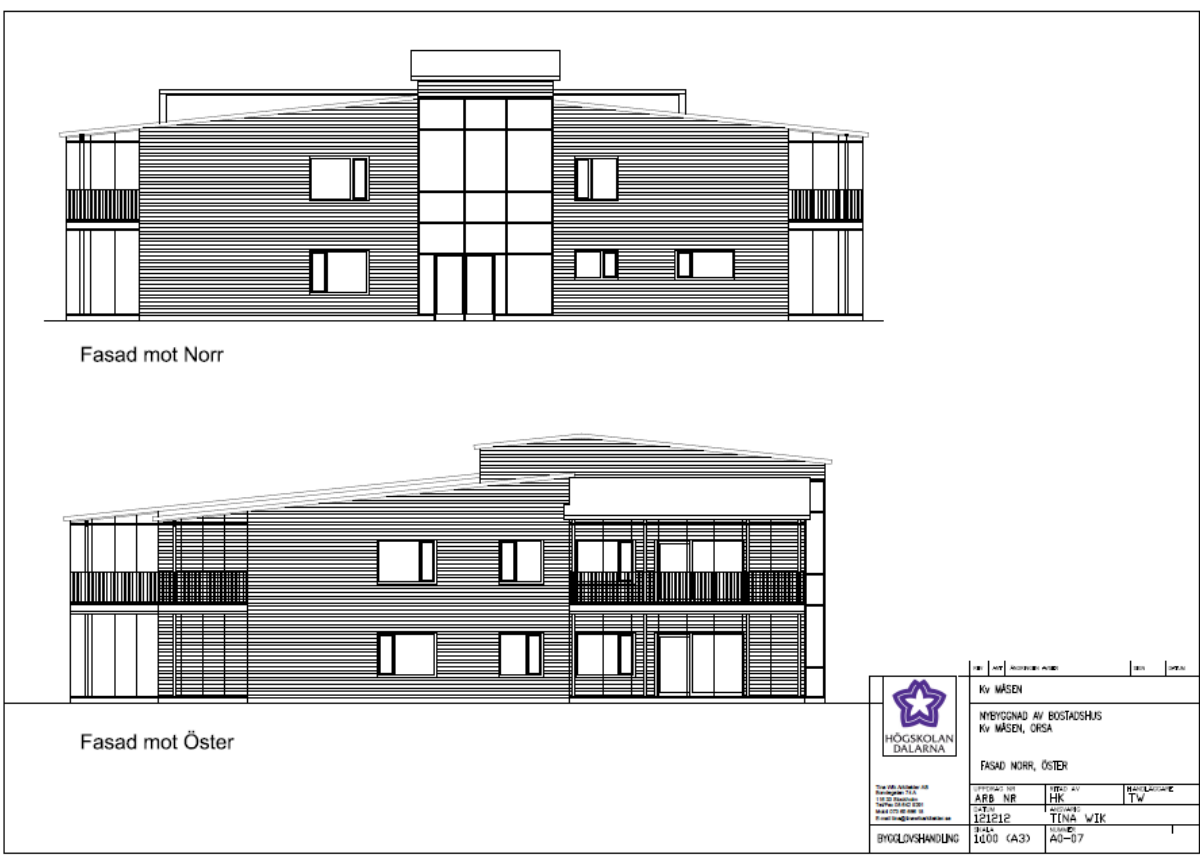
Fasad mot Norr

Fasad mot Öster
